**NUMERICAL AND EXPERIMENTAL STUDIES OF DAMAGE GENERATION
IN MULTI-LAYER COMPOSITE MATERIALS AT HIGH STRAIN RATES**

**I. W. Hall
Department of Mechanical Engineering
University of Delaware
Newark, DE 19716**

This report concerns the results of a S.T.I.R. Program carried out between March and November 2005. The general objectives of the program were to demonstrate the feasibility and utility of a novel use of the Split Hopkinson Pressure Bar (SHPB) as a tool for the investigation and development of multi-layered materials for high strain rate applications.

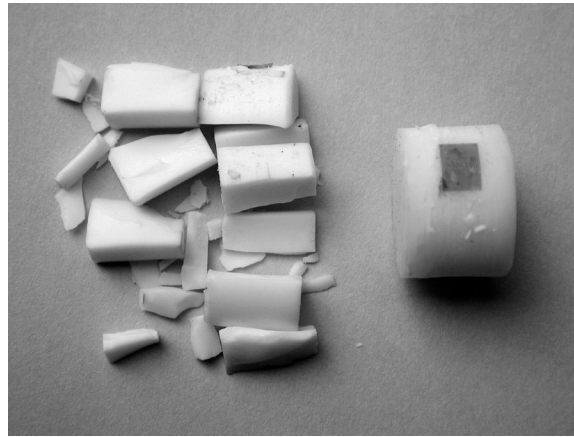
Fig. 18 Ceramic/composite sample after testing at 20.5 m/s.

During testing at high velocities, the ceramic frequently shattered, and various damage modes were activated in the composite. Examination of tested samples confirmed the general trends suggested by the mechanical property data. Fig. 18 shows a ceramic/composite sample after testing at 20.5 m/s in which severe damage has occurred in the ceramic. This figure shows that the dominant fracture mode is one of longitudinal splitting with the generation of, typically, 6 to 12 major fragments. Smaller debris particles arise due to further comminution of the principal fragments.

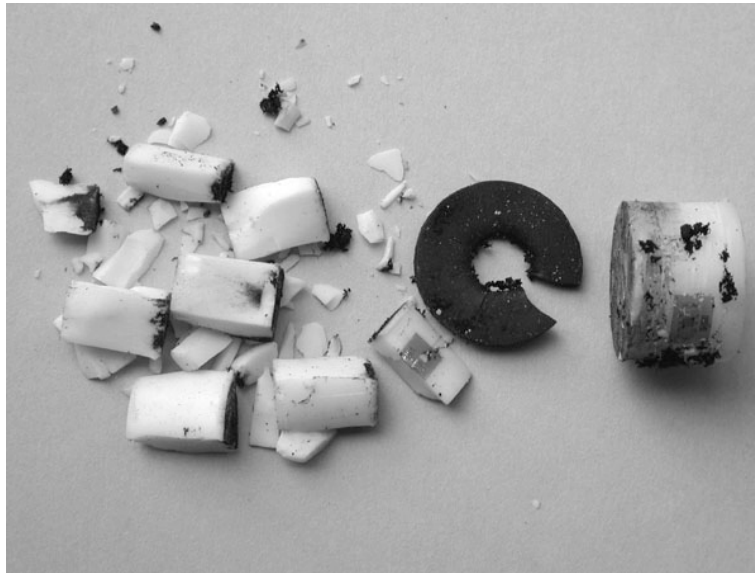
Fig. 23 Unconstrained ceramic/rubber/composite sample after testing at 20.5 m/s.

Fig. 23 shows an unconstrained rubber sample after testing in which severe damage has occurred in the ceramic. Lateral expansion of the rubber during the tests gives it a typical plug and annulus appearance after the test.
